# Manhole Inspection Summary

Manhole # S45KK\_023MH

**Inspection** ☐ Is Incomplete Rating: **3) Fair**

**Location** Address: **Lanvale**

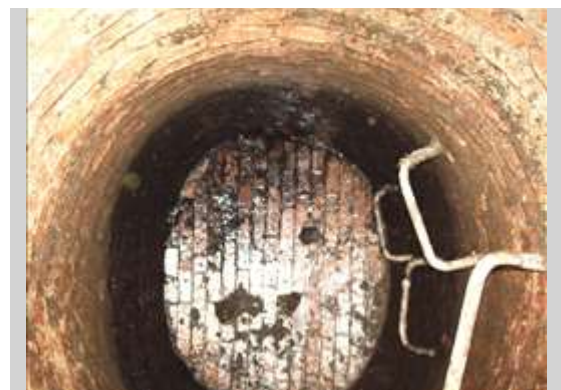
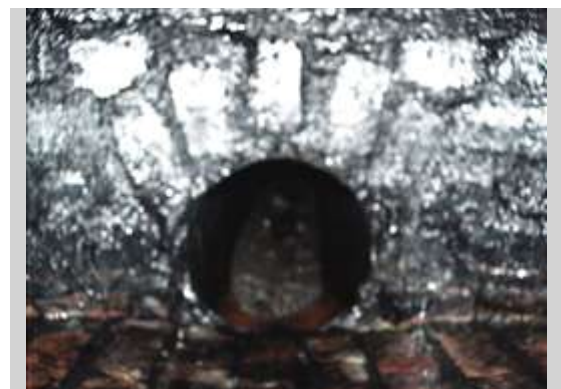
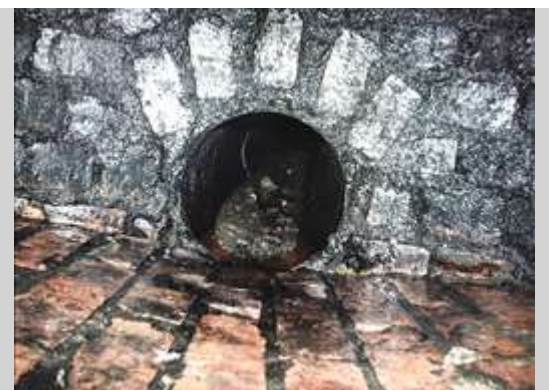
8 in. Circular Gravity Sewer  
Pipe Out @ 12 O'Clock

Pipe Height: **8.4** (in.) Rod and Bar (Angled)  
Pipe Material: **Clay** ☐ Pipe Lined  
Invert Depth: **9.17** (ft.) Flow Characteristics: **Slow**  
Deposits: ☒ None ☐ Mud ☐ Sludge ☐ Debris ☐ Grease  
Silt Depth: (in.) Deposits Extent:  
Infiltration: **None** Pipe Seal Cond: **Sound**
